**Hardchrome Electro Plating, Inc.**  
**Draft Upland Site Summary**

**HARDCHROME ELECTRO PLATING, INC. (DAR SITE ID #124)**

Address: 8 Meserole Avenue, Brooklyn, New York 11222  
Tax Lot Parcel(s): Brooklyn Block 2614, Lot 8  
Latitude: 40.725453  
Longitude: -73.957012  
Regulatory Programs/  
Numbers/Codes: USEPA No. NYD002020758, AFS No. 3604703034  
Analytical Data Status: ☐ Electronic Data Available ☒ Hardcopies only  
☐ No Data Available

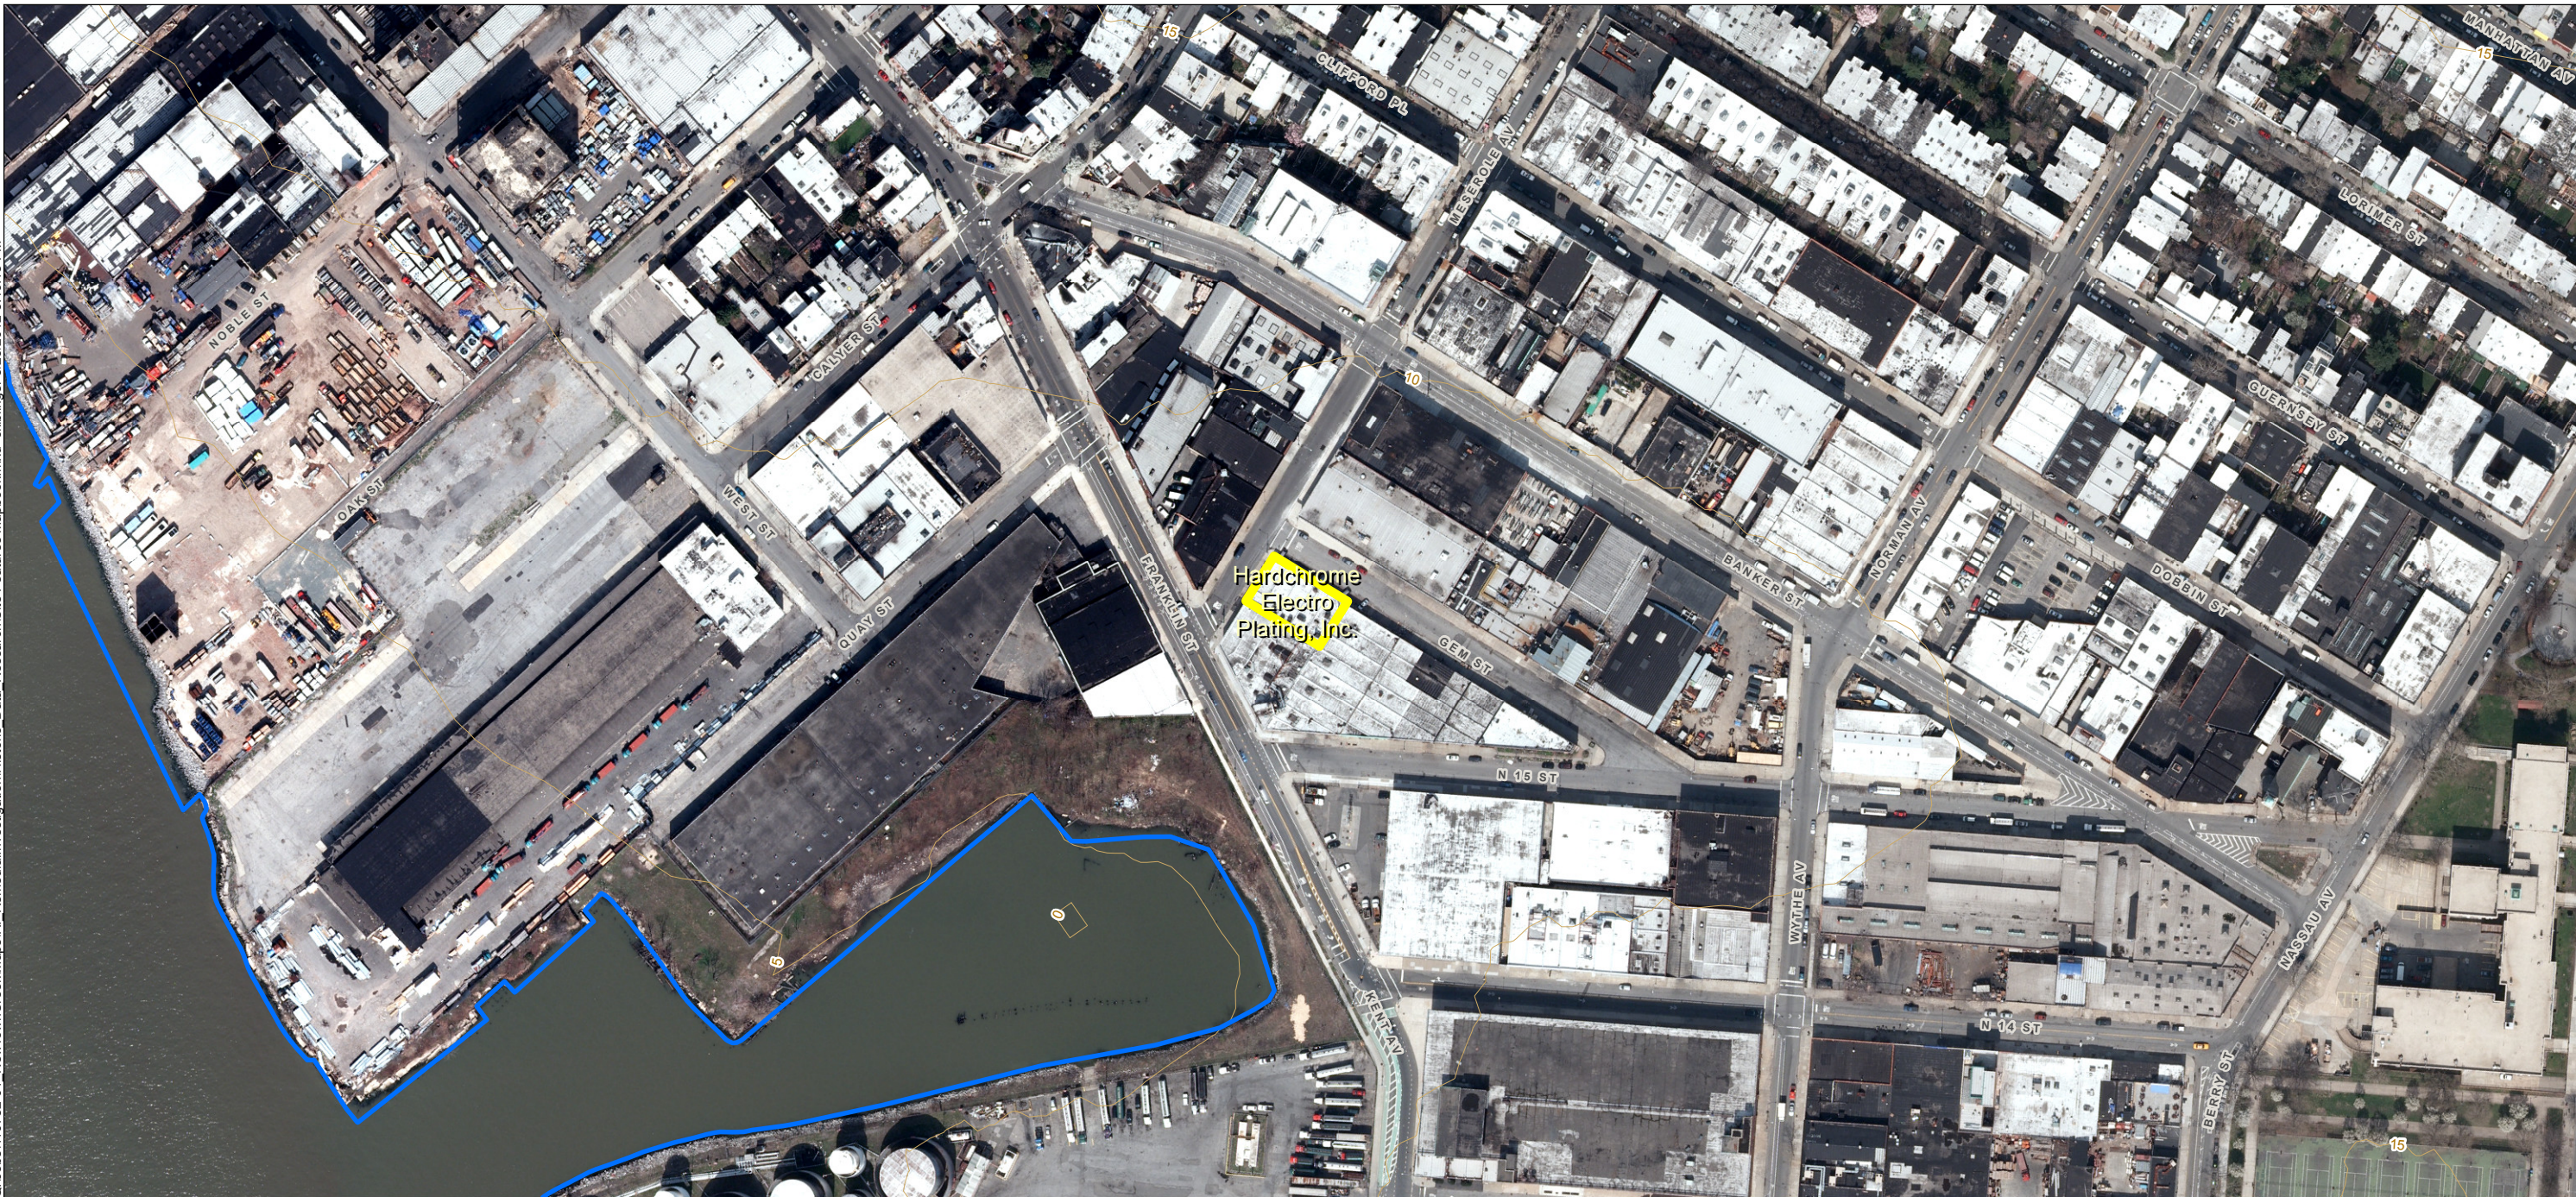
Figure 1 Site Vicinity Map: Hardchrome Electro Plating, Inc.

The site occupies approximately 0.14 acre<sup>1</sup> in Brooklyn, New York, and is located approximately 0.66 mile south of Newtown Creek and approximately 300 feet east of the East River. The site is between 5 and 10 feet above mean sea level and site topography gradually slopes to the west as shown on Figure 1. The entire site is covered by a building. The site and adjoining properties are zoned for manufacturing; a residential zone is located to the northwest of the site (NYCDP 2011).
